## SET FOR THE GERBER RESILIENCE TEST

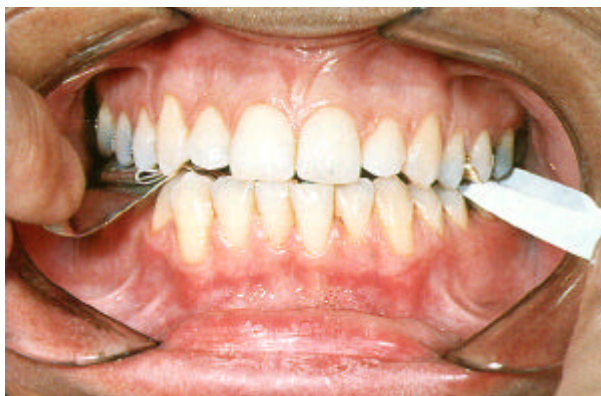
**Figure 1** Illustrates a resilience test on a patient. On the right hand side, 2 layers of 0.3mm special tinfoil have been placed between the occlusal surface of the second premolars. On the left, the testing foil is visible between the molars. When the patient bites down lightly he should, under normal circumstances, be able to make molar contact on the contra-lateral

left side, keeping the test-foil clenched, despite the bite being blocked on the right side.

**Example 2** Layers of 0.3mm special tinfoil, placed between the second premolars cause premature contact of 0.6mm when biting down. When the teeth make their first light contact, the molars on the opposite side have not (yet) made contact. Now, when biting down just a little, the mandible will execute a tilting movement around the premature contact, until the teeth also make contact on the opposite side in the molar region. Thereby, the condyles on the right will be cranially shifted. However, this can only occur when, thanks to its resilience, the "discus articularis" is compressed until the occlusion of the teeth stops the shifting of the condyle in the joint-fossa. The healthy patient should be able to clench a thin-foil between the molars on the right. To test the resilience of the TMJ, the artificial blocking of the bite should be fitted on the opposite right hand side.

The "**Gerber Resilience Test**" use of 0.3mm special tinfoil allows step-by-step checking of the "discus articularis". One keeps adding additional layers of 0.3mm special tinfoil, making the blocking of the bite progressively greater, until the patient is no longer able to clench the contra-laterally placed test-foil. The normal range for these values is between 0.6 and 0.9mm and, sometimes, even up to 1.2mm.
